Asbestos NESHAP & Lead Survey

Performed at:
Lake City VA Medical Center
619 South Marion Avenue
Lake City, FL 32025

OHC Project #160028-AL

**Re: Asbestos NESHAP & Lead Survey
Lake City VA Medical Center
Mechanical & Plumbing Improvements Project
Buildings 19, 38 & 64
OHC Project No. 160028-AL**

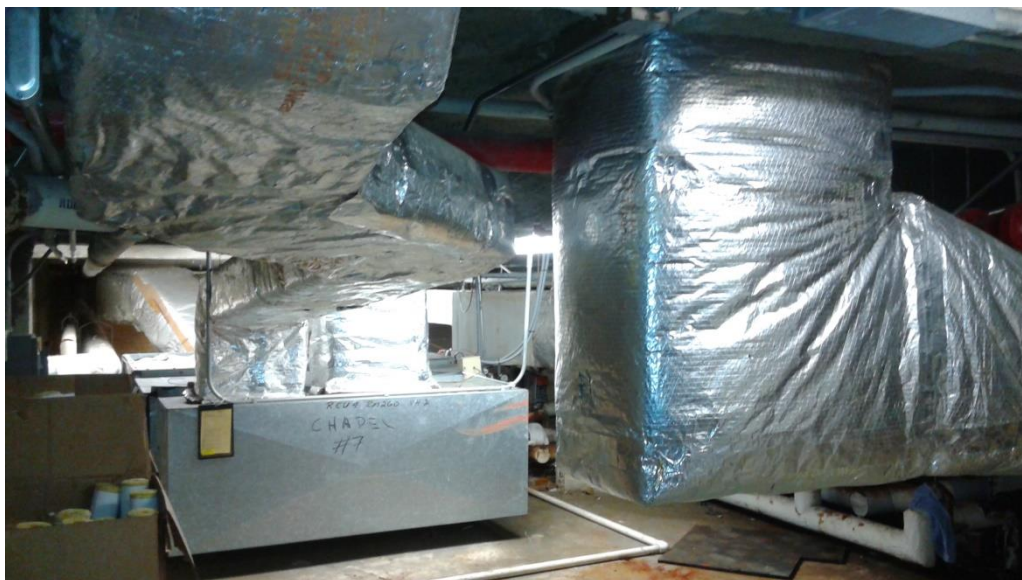
Mechanical Room BB26 in Building 64, showing AHU and ductwork

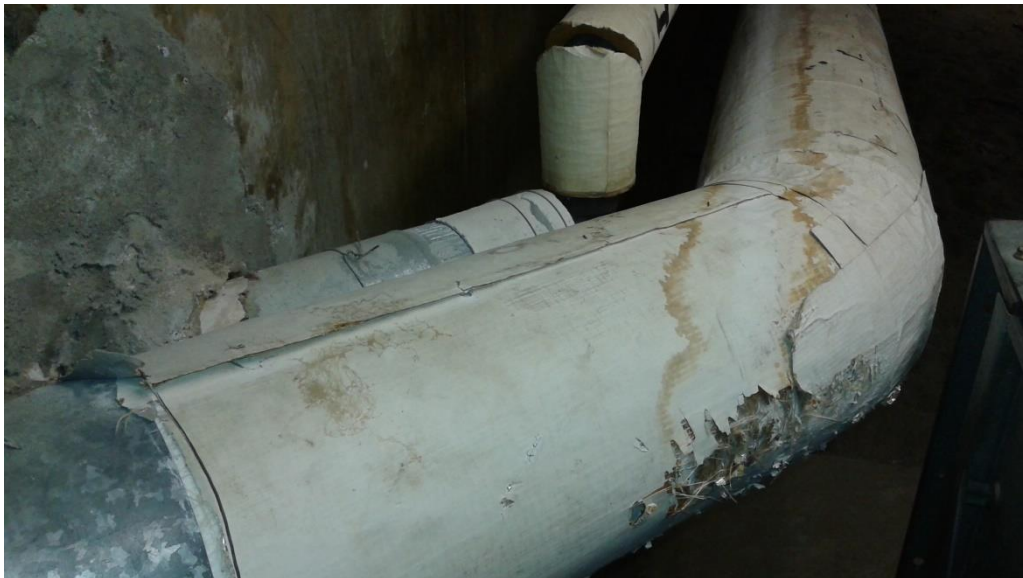
Large water pipe within Room BB26 of Building 64
[HSA-3 & HSA-4]

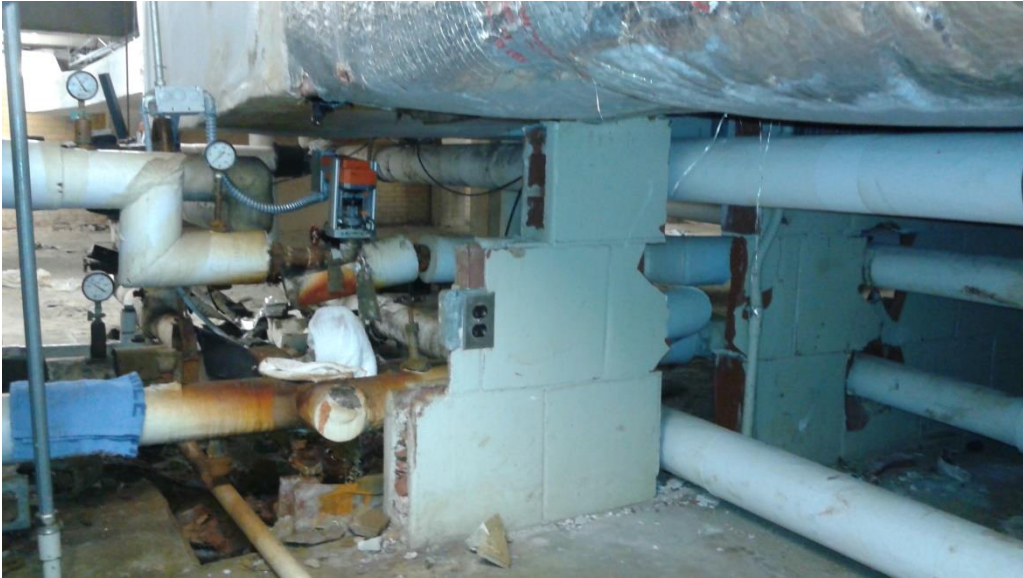
Water pipes located throughout Room BB26 in Building 64

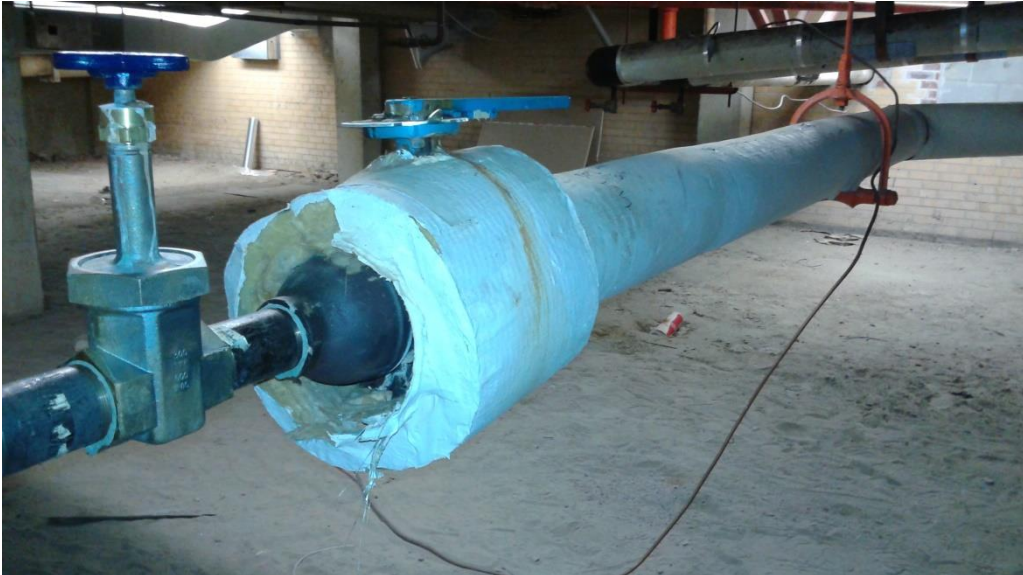
HSA-8

White mastic associated with steam water pipes
[Building 64 Room BB26 – AHU-6 & AHU-7]

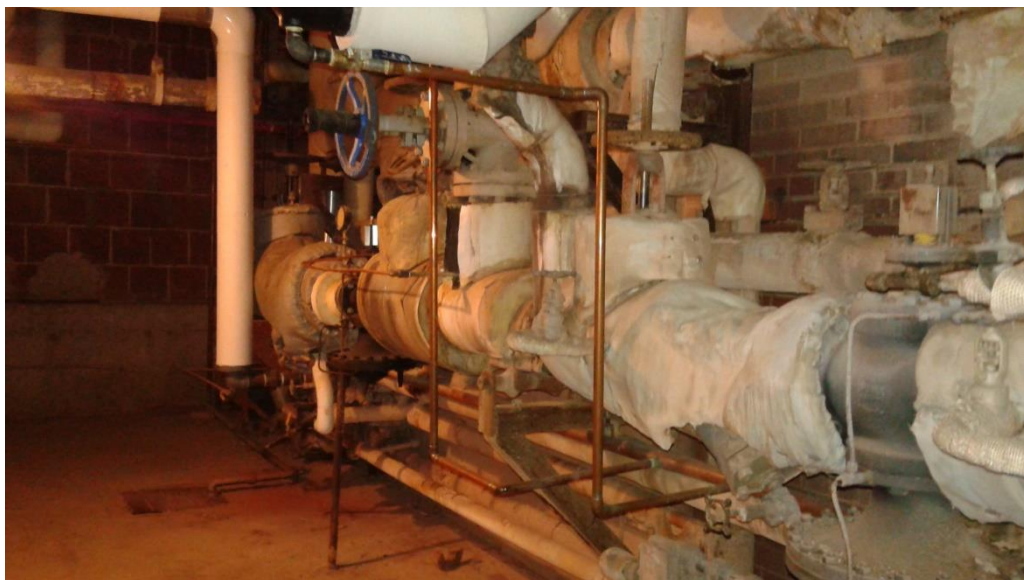
Boiler Room AB05 in Building 64

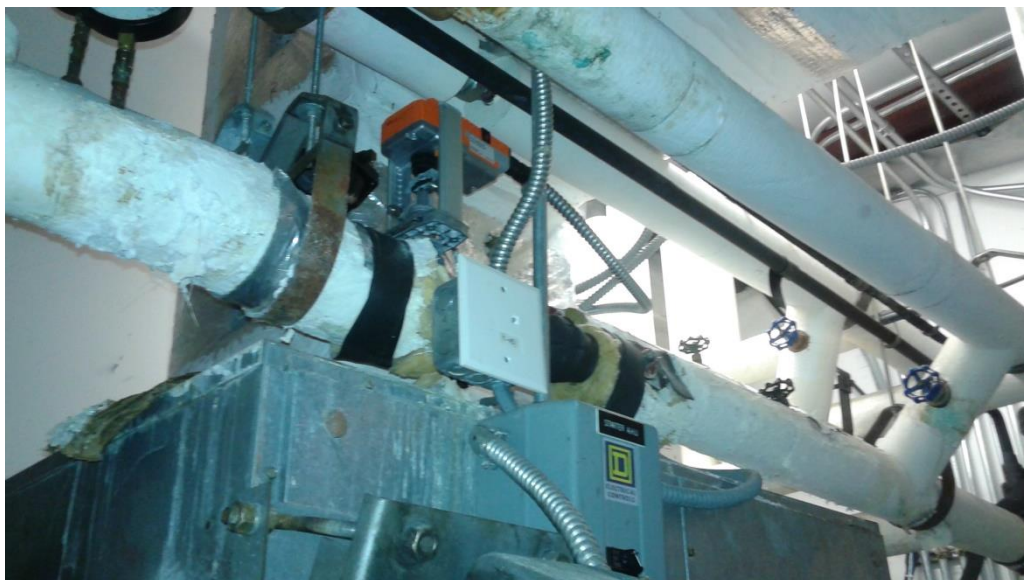
Mechanical Room AB18K in Building 64

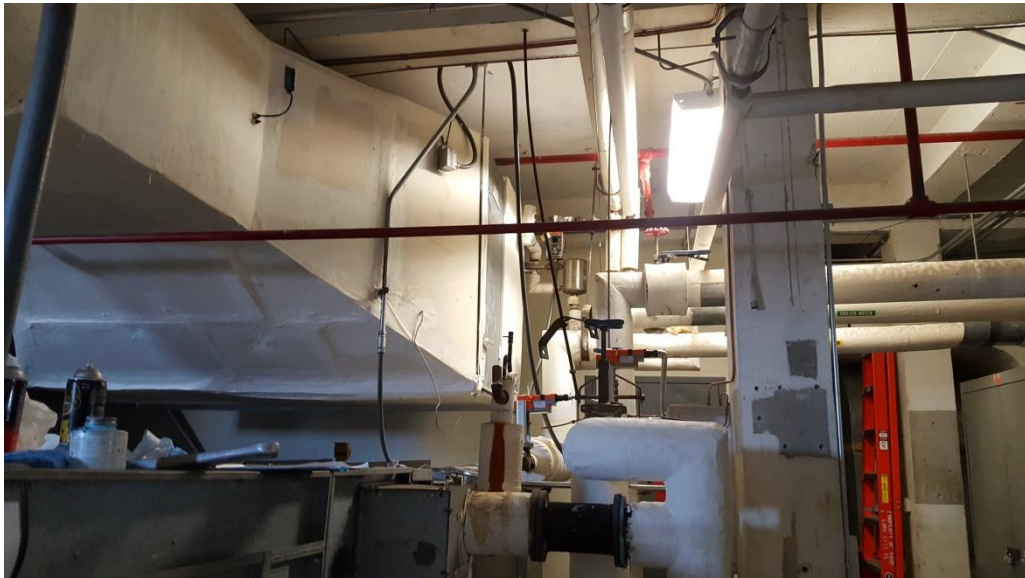
Penthouse B of Building 64

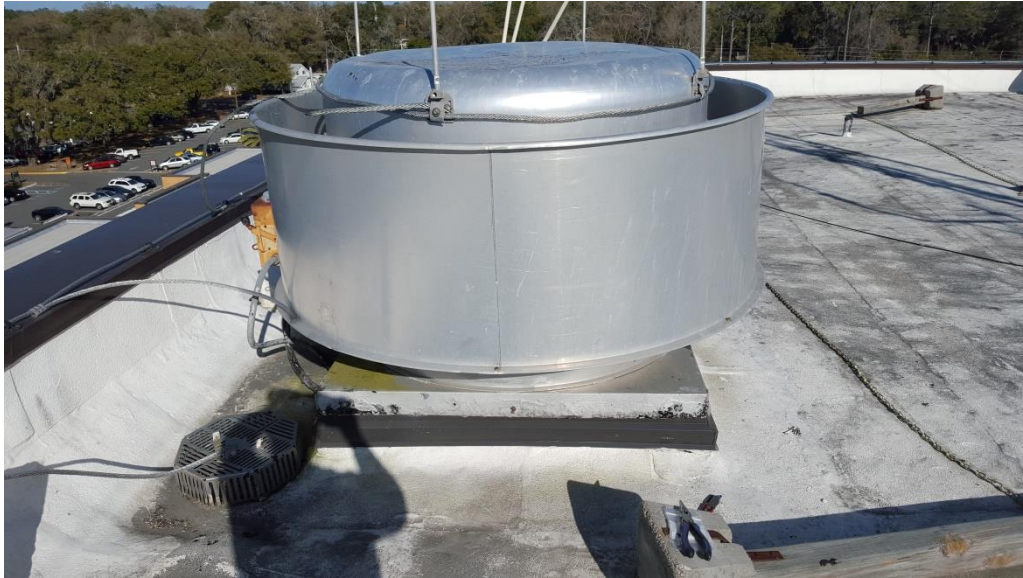
Exhaust fan on rooftop of Penthouse B in Building 64,
containing **HSA-34 (ACM)** and **HSA-35 (ACM)**

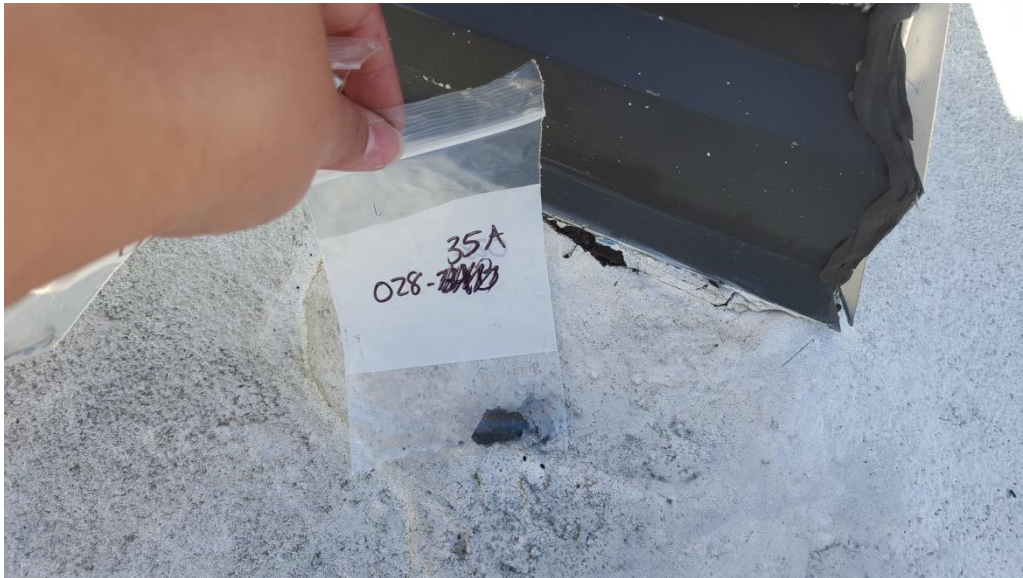
HSA-35

White & black mastic between roof and exhaust fan
[Building 64 Penthouse Rooftop – AC-53]

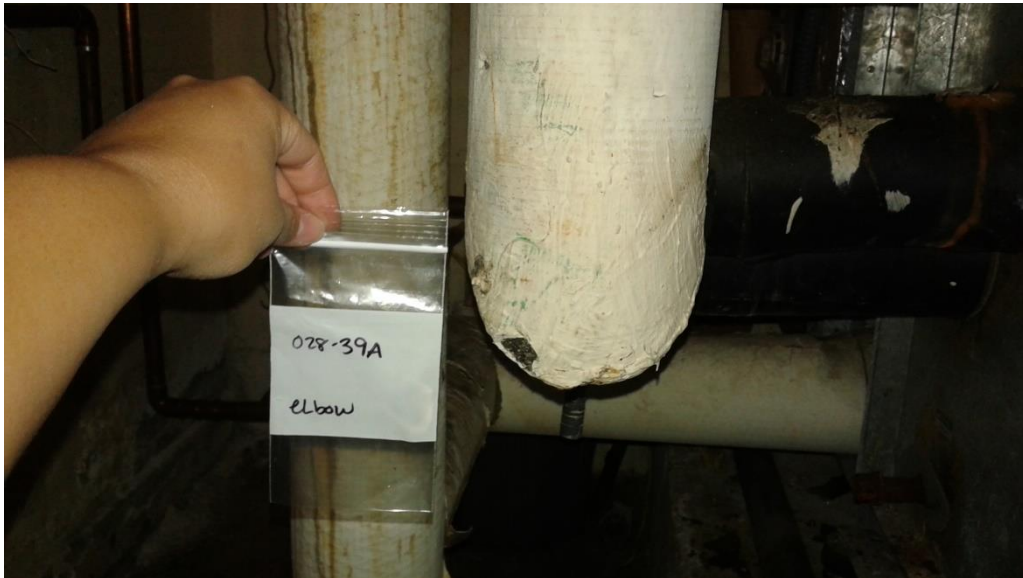
HSA-39

White mastic associated with black stink rock on chilled water pipe
[Building 19 B9A – AC-6]

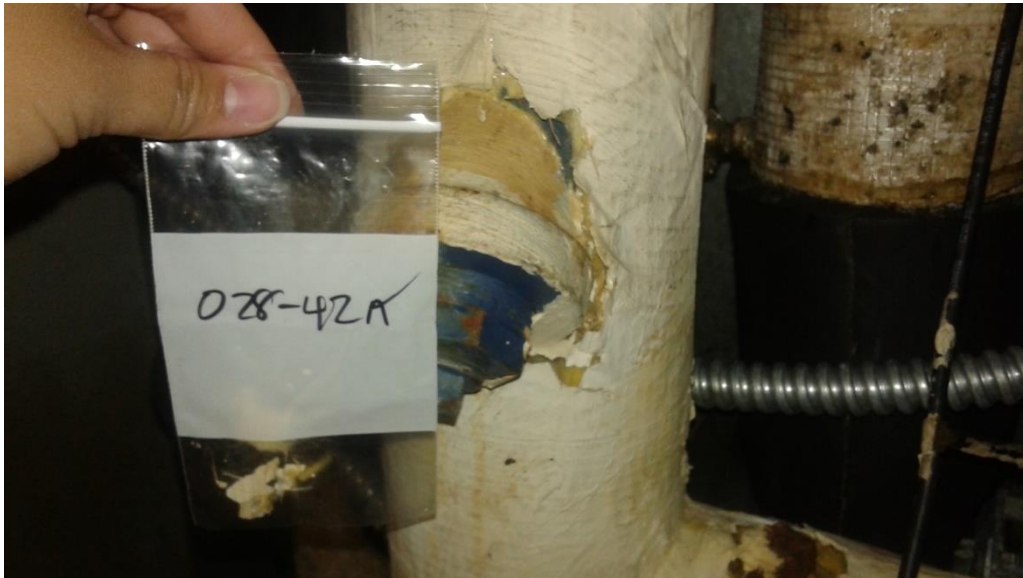
HSA-42

White mastic associated with yellow insulation on hot water pipe
[Building 19 Room 115 – AC-5]

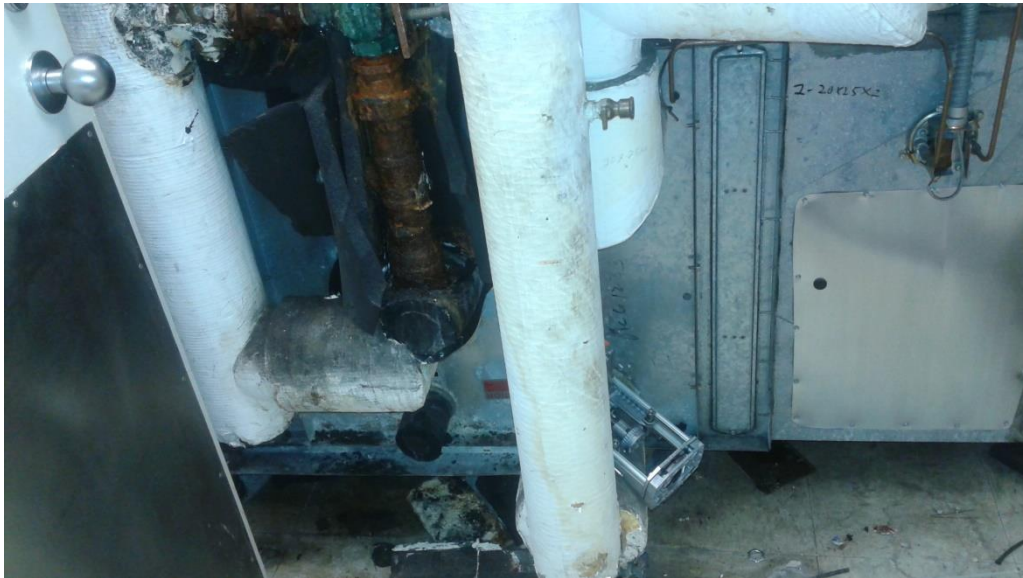
AC-4 located in Room 103 of Building 19

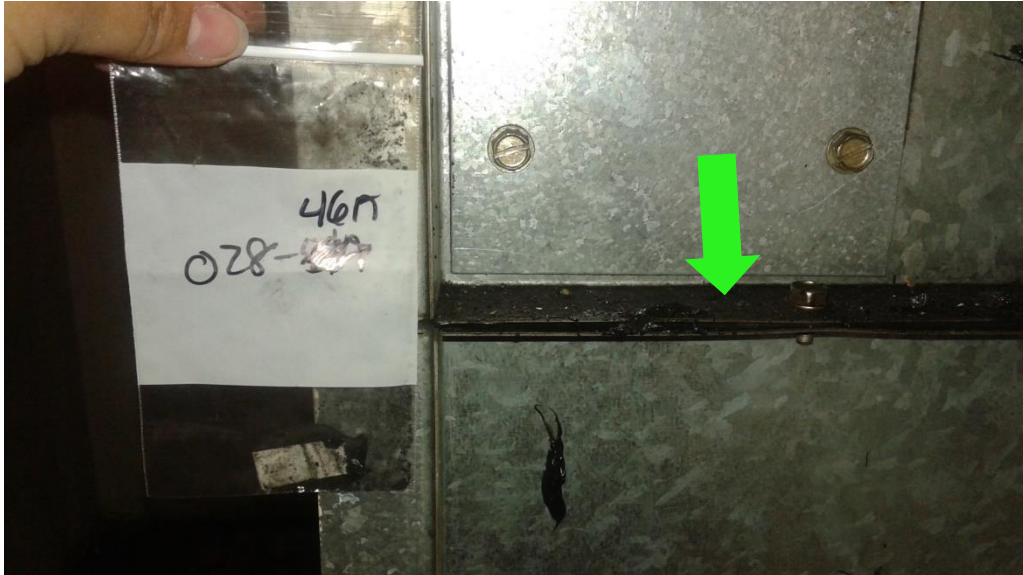
HSA-46
Black gasket between metal panels on AHU
[Building 19 Room 103 – AC-4]

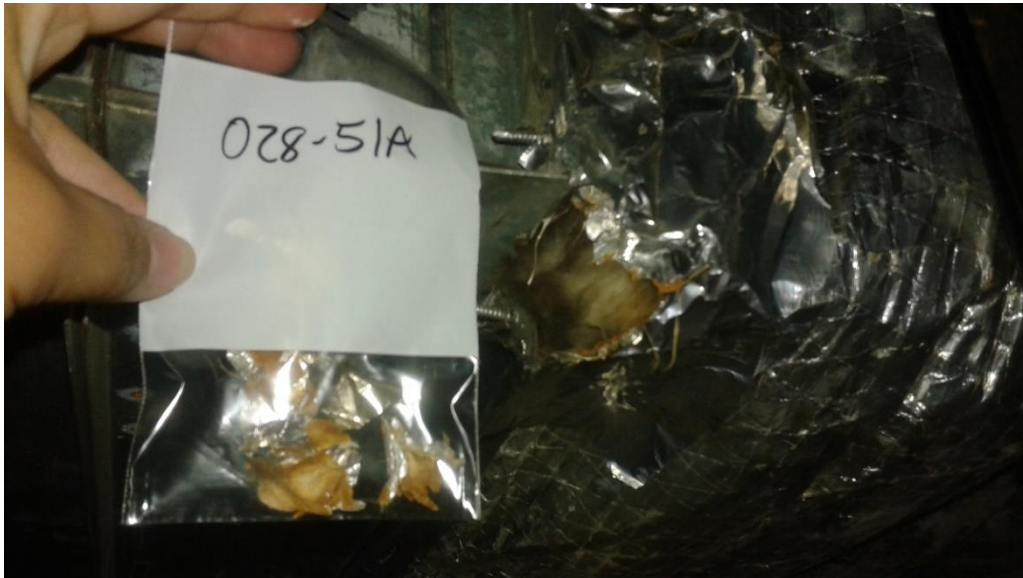
HSA-51

Brown mastic associated with black fiberglass insulation and wrap on ductwork [Building 19 Canteen plenum – AC-2]

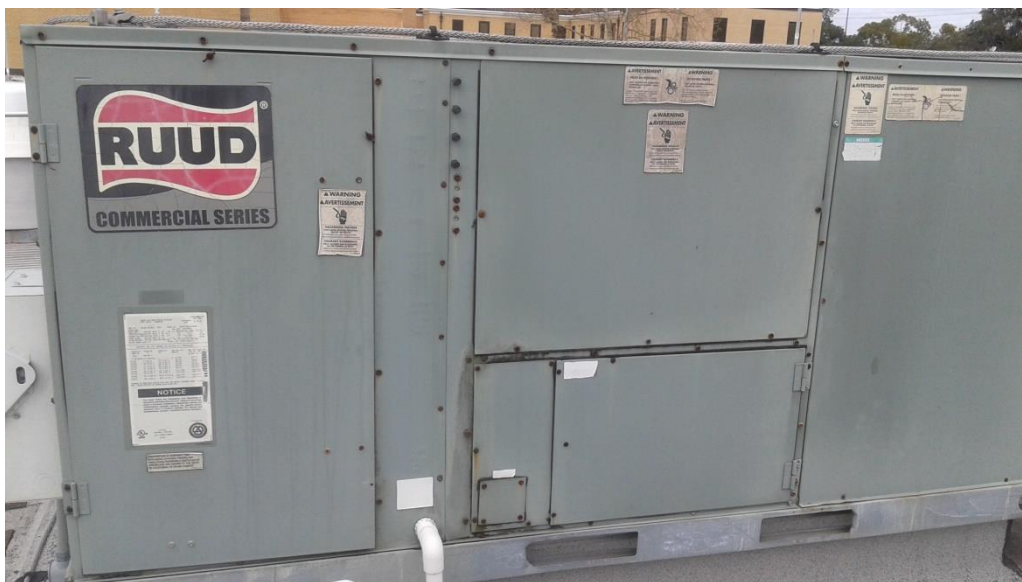
RUUD unit on kitchen rooftop of Building 19

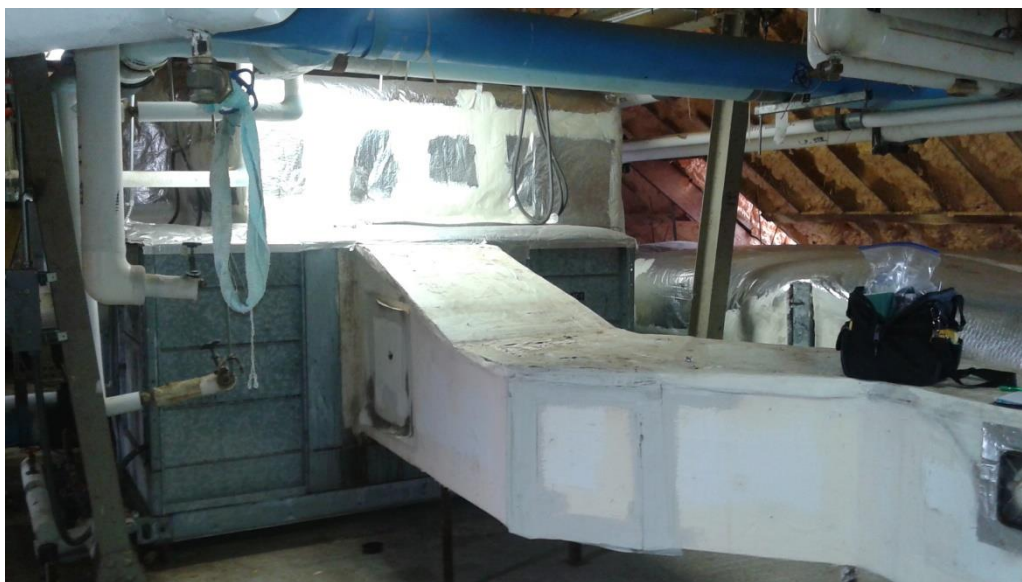
Attic Area of Building 38

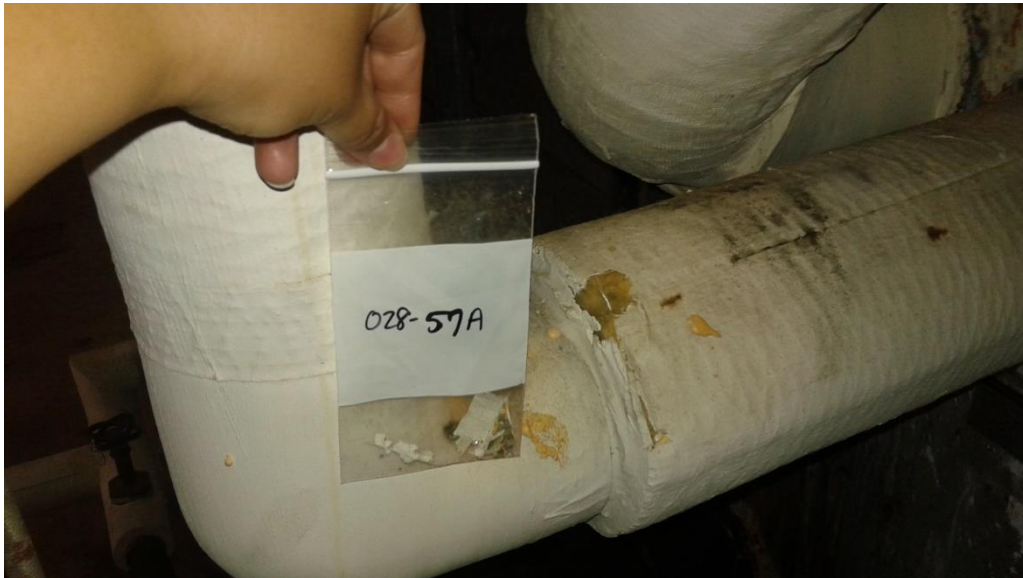
HSA-57

White mastic associated with yellow insulation and wrap on condensate pipe [Building 38 Attic Area – AHU-1 & AHU-2]

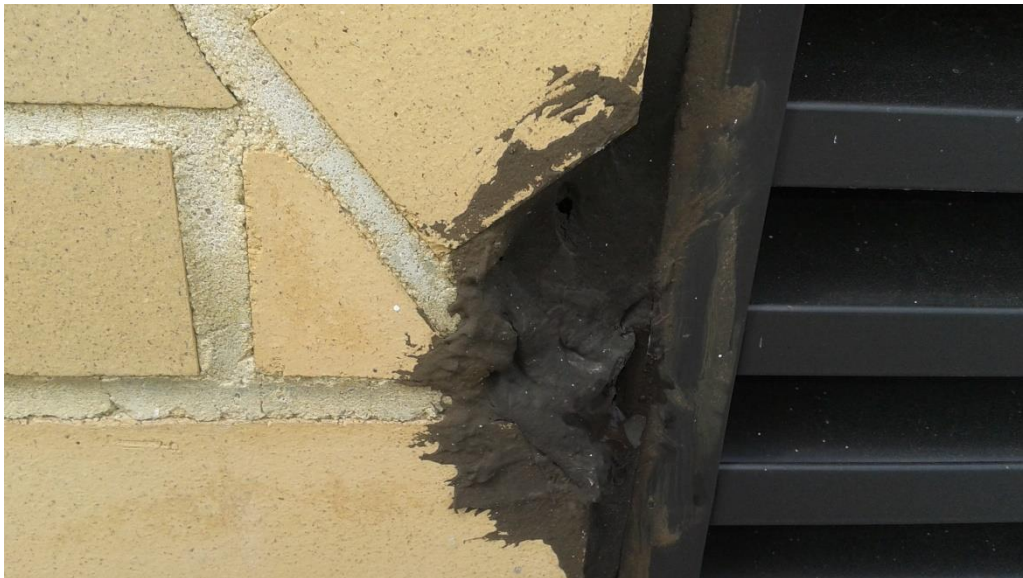
HSA-61

Black caulking around exterior louvre
[Building 38 Rooftop Area]
